Acton Boxborough Regional School District School Facilities Assessment

Progress Presentation

19 November 2015

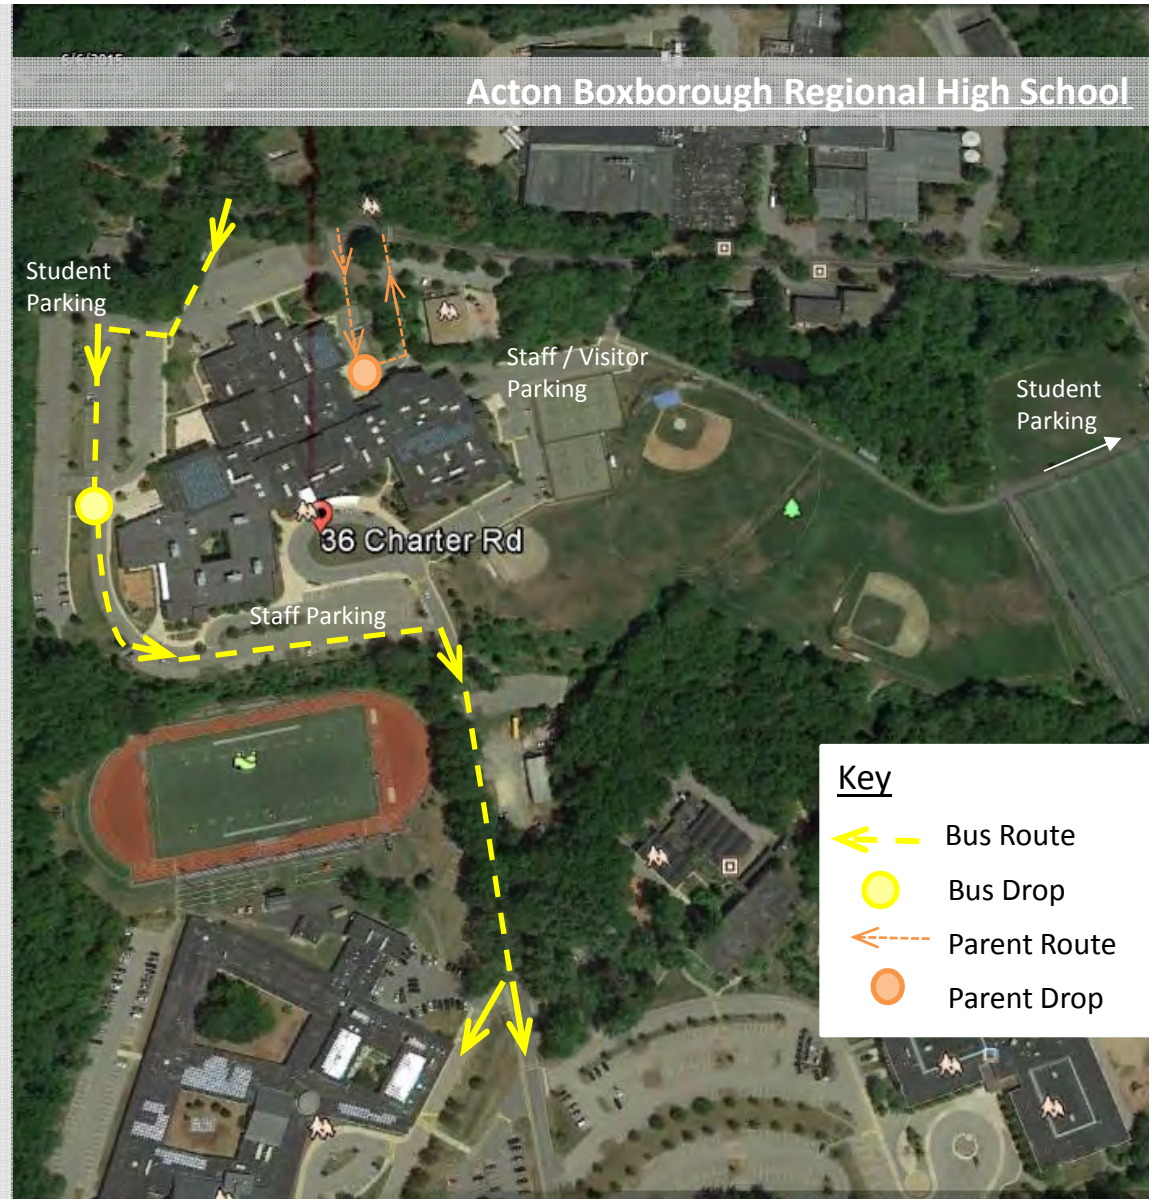
- Failed, patched and uneven concrete sidewalks and steps
- Pavement aging and cracking
- Convoluted, circuitous vehicular pattern
- Lack of pedestrian walks at parking lots
- Lack of identification/signage
- Lack of access to Leary Field
- Field irrigation is reported to not function well
- Review parent drop-off
- Pedestrian access to school from Rte 111; difficult and not wide enough

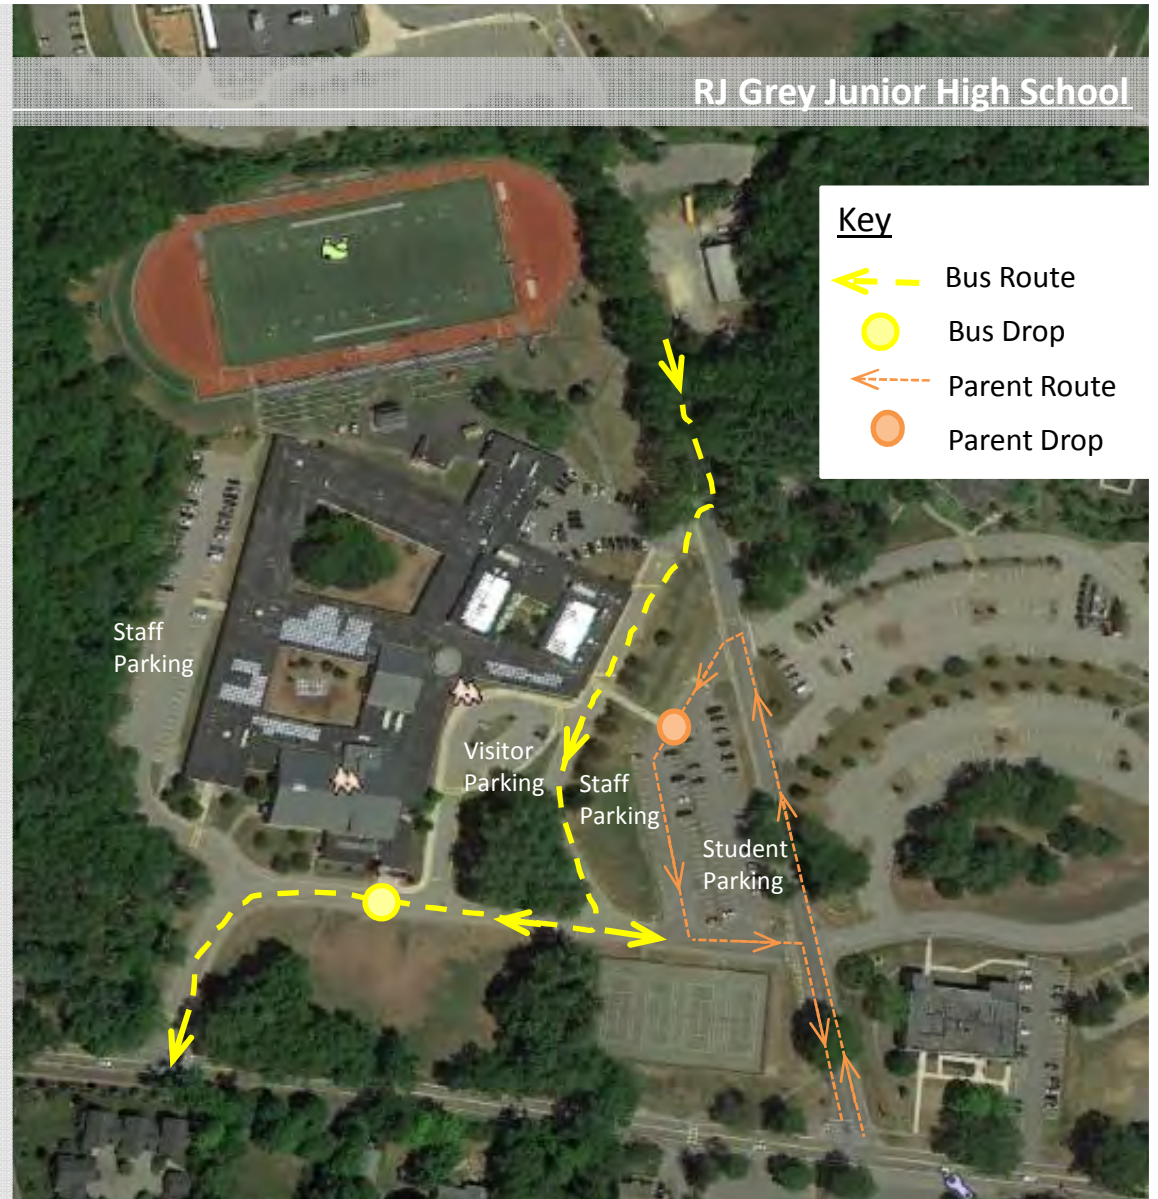
- Circulation is confusing - directional signage needed
- Pavement and sidewalks: overall fair condition
- Minor concrete curb replacement needed
- Cracking at drives and asphalt walkways; drainage issues/ponding; repave to resolve ponding
- HC pkg spaces – provide direct access to crosswalk/sidewalks
- No HC access to Leary Field
- No continuous path around building
- Parking -sufficient
- Parking during events - insufficient
- Lack of screening at service area

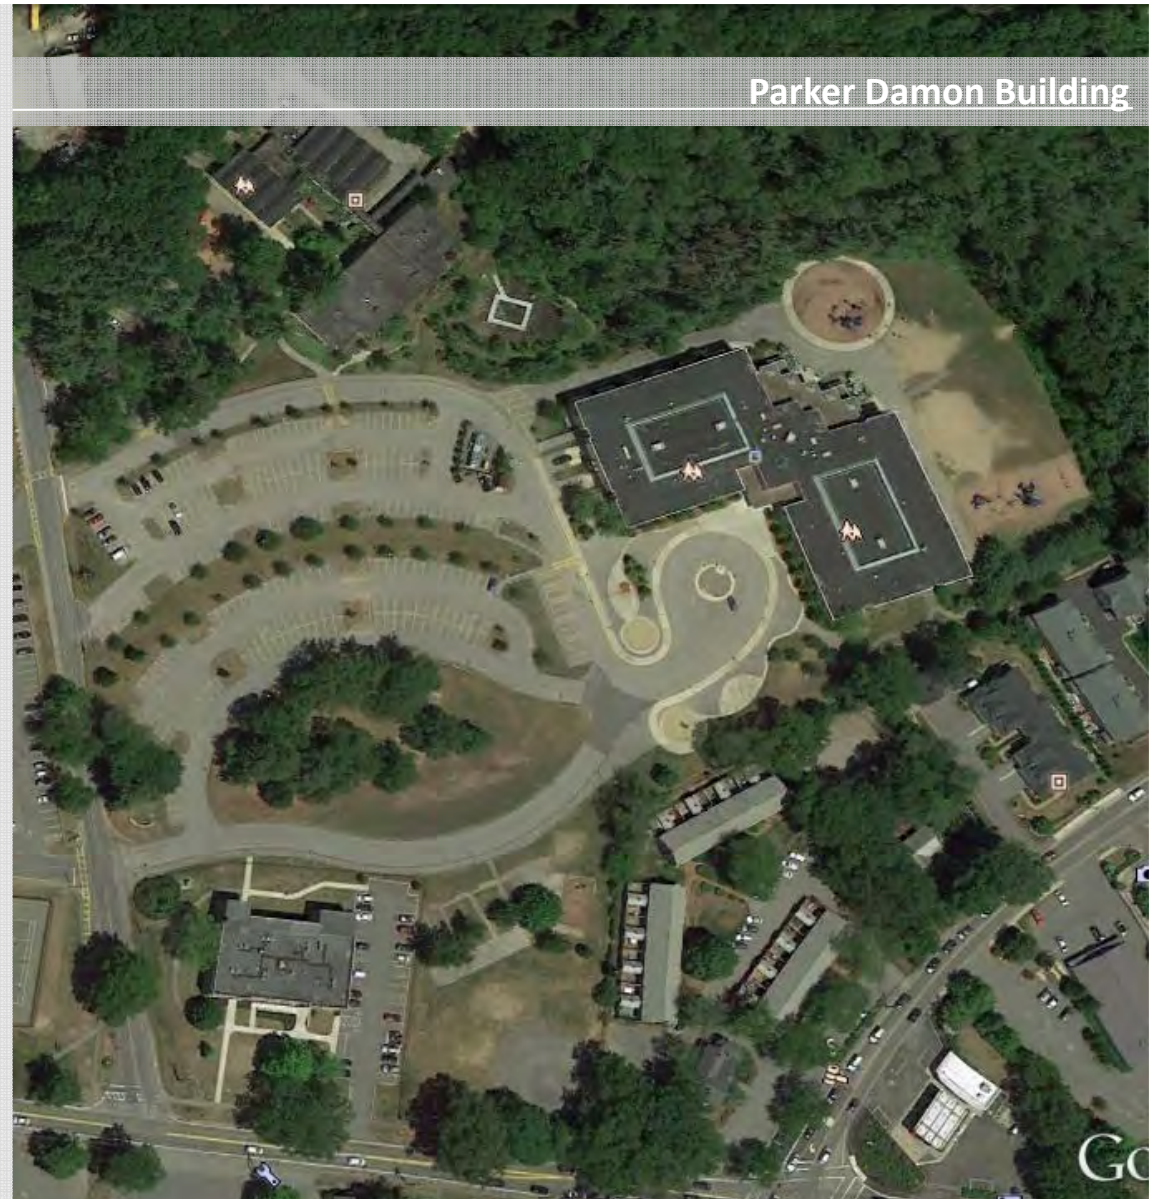
- Provide better directional signage for circulation pattern
- Too much paving at building entrance, lack of greenery
- Concrete curb replacement needed at some locations
- Ponding in parking lots
- Drainage issues at large landscape island bordering Charter Road; repave to resolve ponding
- Accessible parking and travel route may not be compliant
- Play area lacking shade trees
- Lack of screening at service/delivery area
- Parking lot should have more pedestrian walks

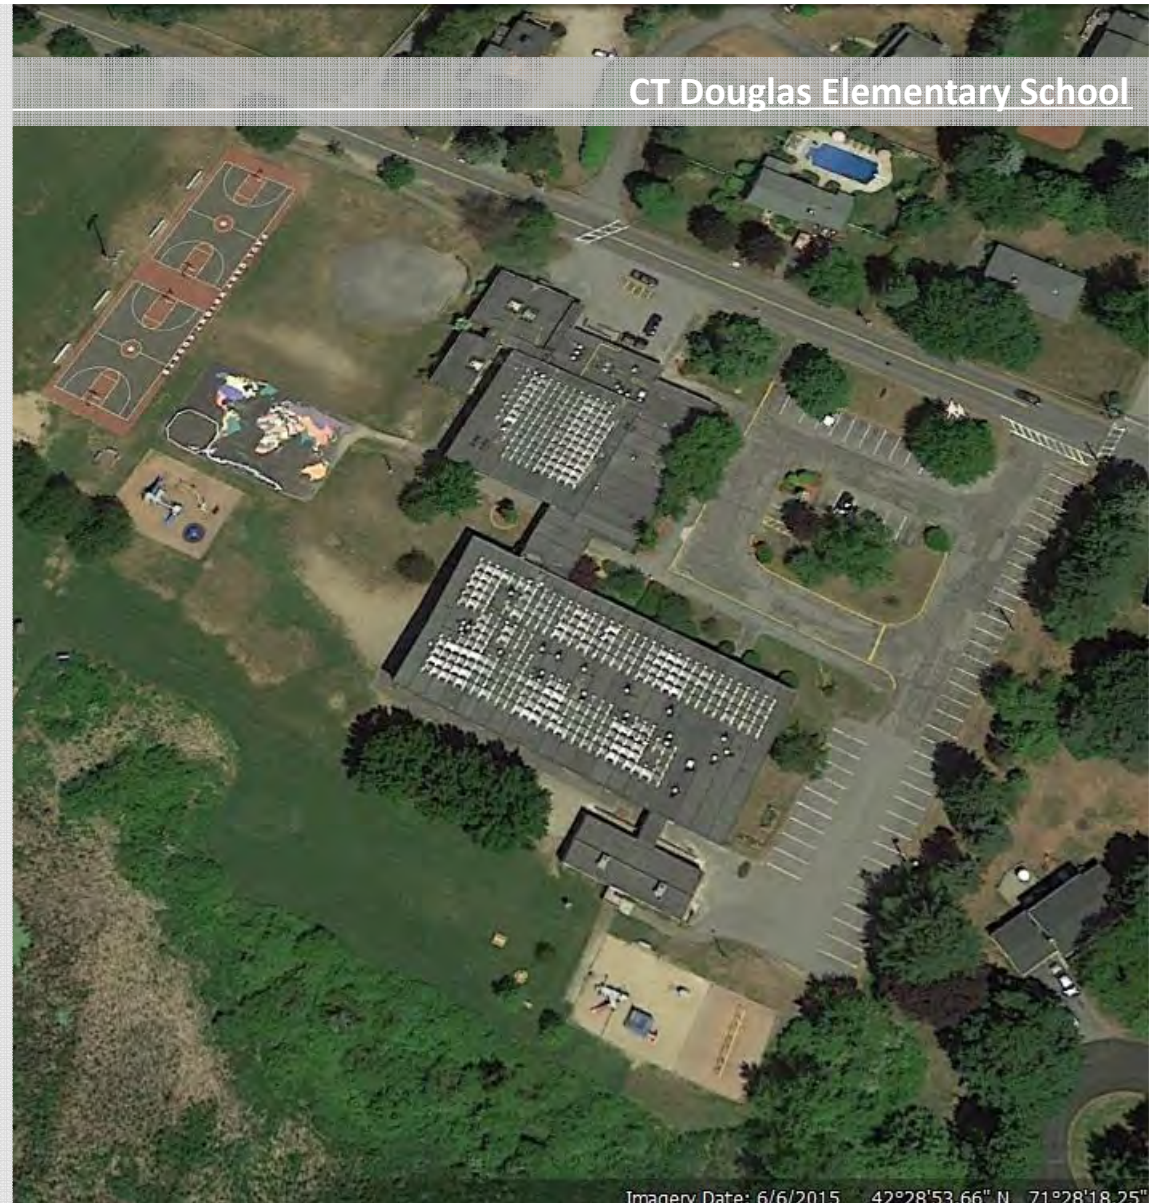
- Only one loop for parent drop-off, busses and parking; no separation – safety concern
- Significant congestion and traffic back-up on Elm St.
- Only 4 busses at a time; staggered arrivals
- Only one access into the site; site is constrained
- Asphalt and sidewalks are in fair to poor condition
- Inadequate parking
- 2 HC spaces; needs crosswalk

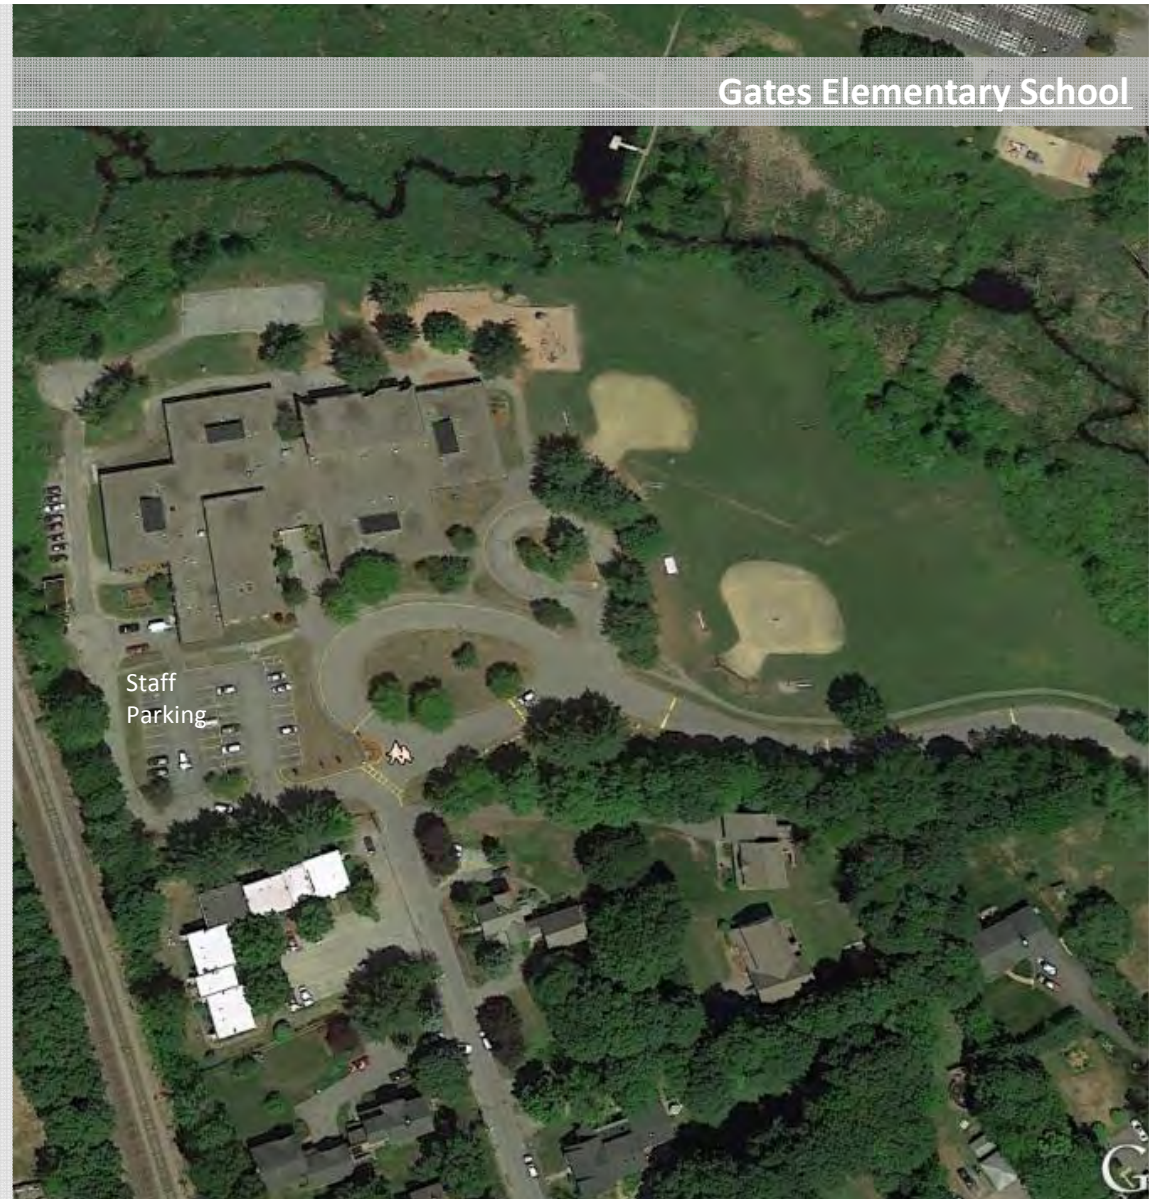
- Pavement and sidewalks: overall worn and in need of overlay/replacement
- Some concrete curb replacement needed Rear paved court in poor condition
- Circulation – Bus and car traffic intersect; turning radius at Spruce street is insufficient
- Car loop is within parking lot – safety concern
- HC parking spaces – provide direct access to crosswalk/sidewalks
- Parking - insufficient
- Screening at service area
- No continuous path around building

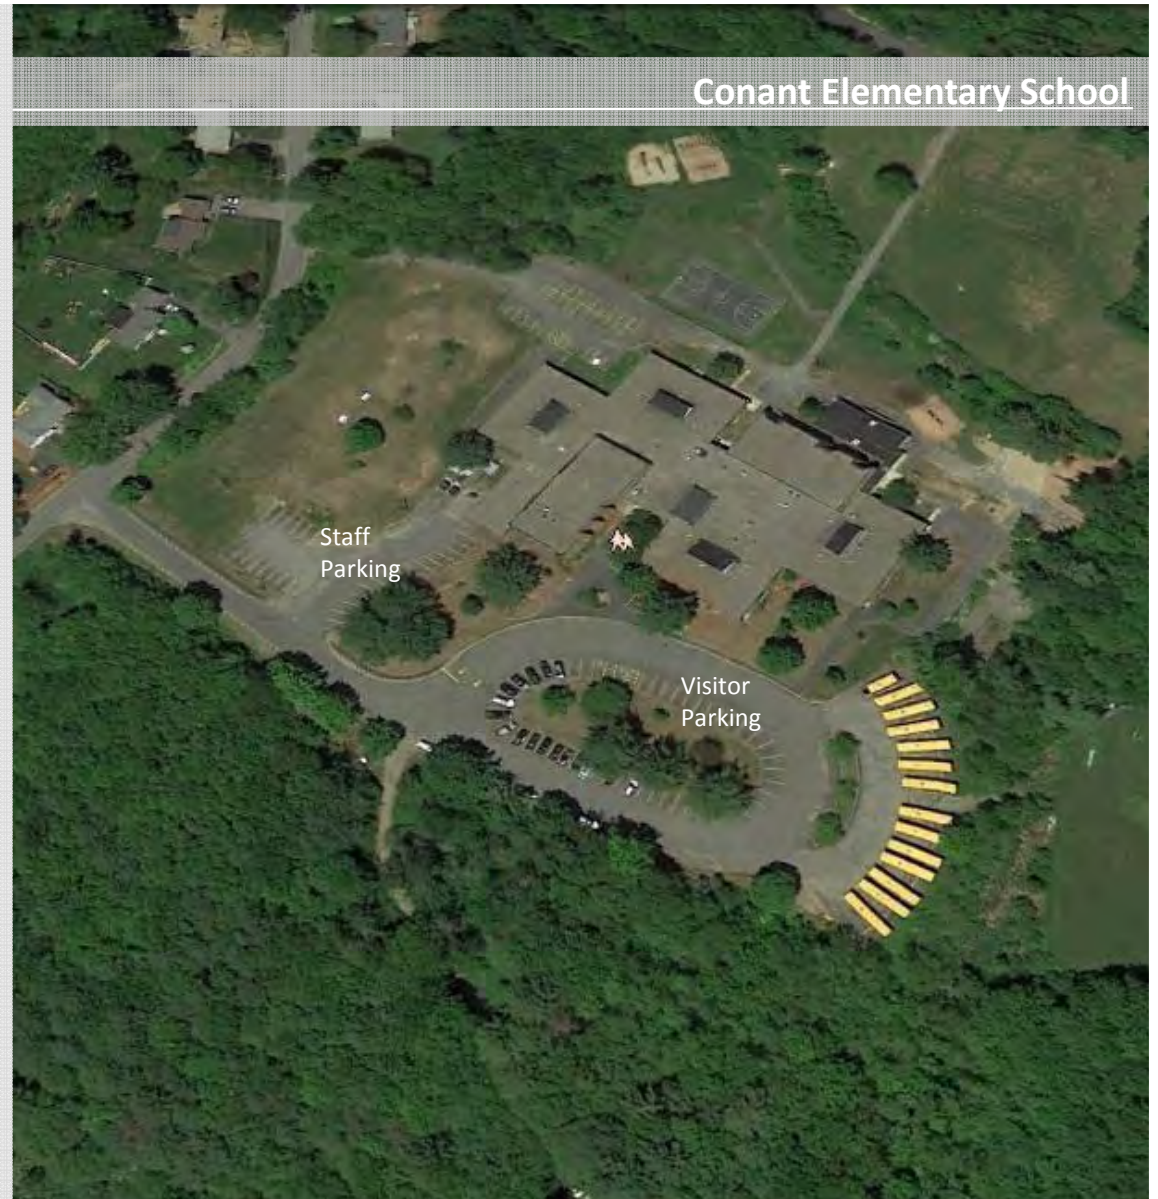
- Pavement and sidewalks: overall worn and in need of overlay/replacement
- Repair curbing, provide curbing where it doesn't exist
- Lack of accessible travel path to building entry
- Lack of accessible path to new playground
- Circulation – Bus and car traffic share loop drive, consider separation
- Screening at service area
- Consider separating bus and parent drop offs
- Analyze congestion problems, possibly provide second access drive to site
- Consider new full depth pavement at receiving area and access
- No continuous path around building

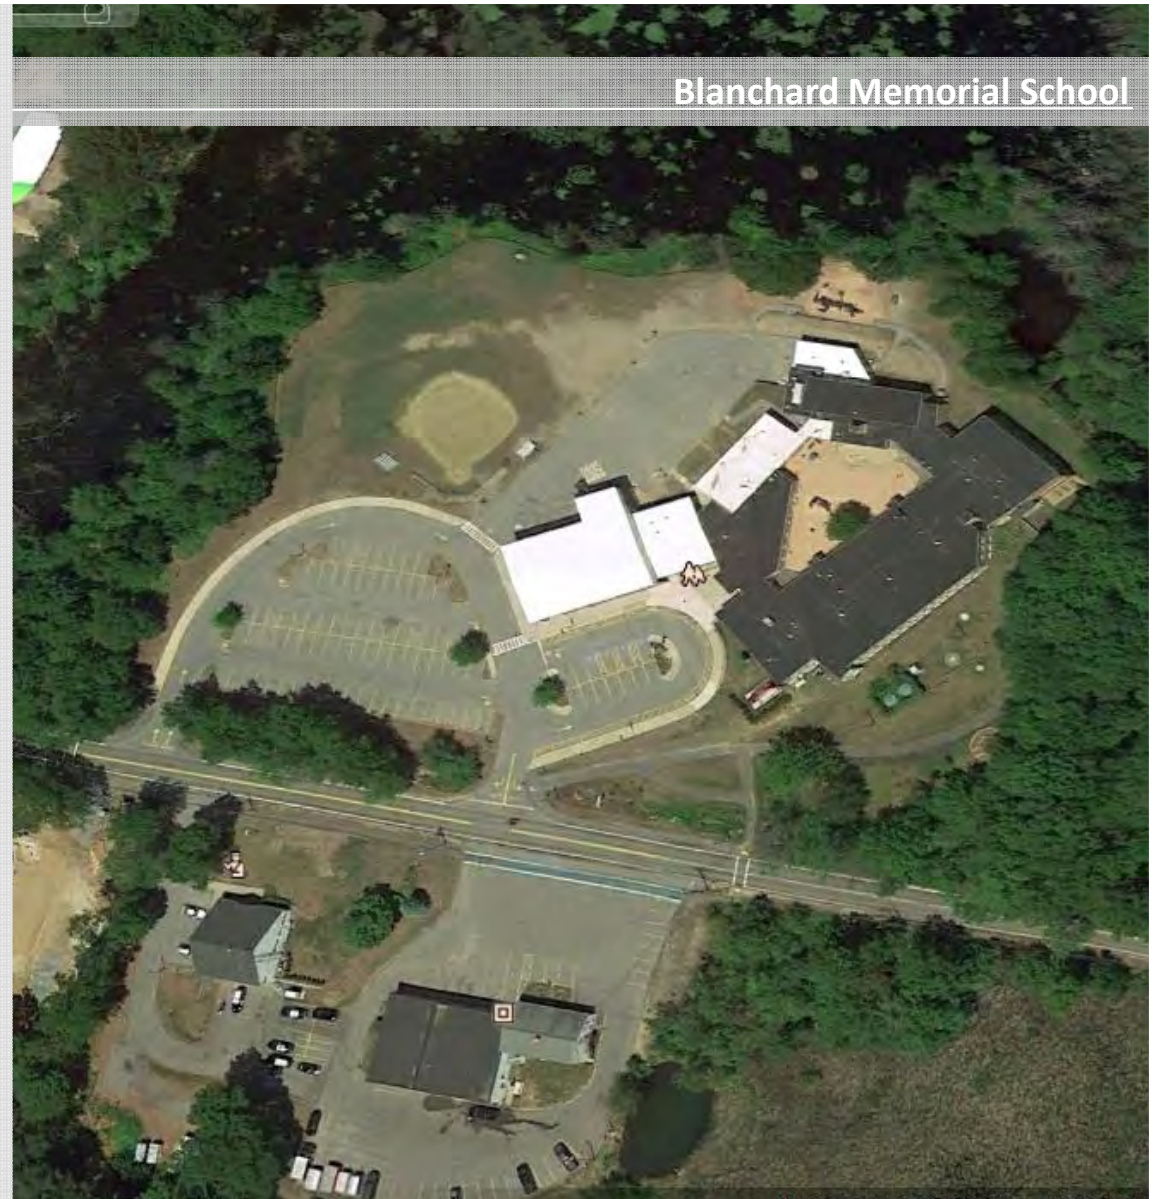
- Provide new site signage
- Pavement and walkways: worn and cracked
- Ponding in parking lot and degraded areas
- Concrete curb replacement needed
- HC pkg spaces – provide direct access to crosswalk/sidewalks
- No continuous path around building
- Parking -sufficient
- Athletic field is worn
- Separate service area from play area
- Mounded dirt area is inhibiting natural flow into bioretention basin
- Catch basin and pipe leading to bioretention basin is in bad condition and has settled resulting in stagnant water

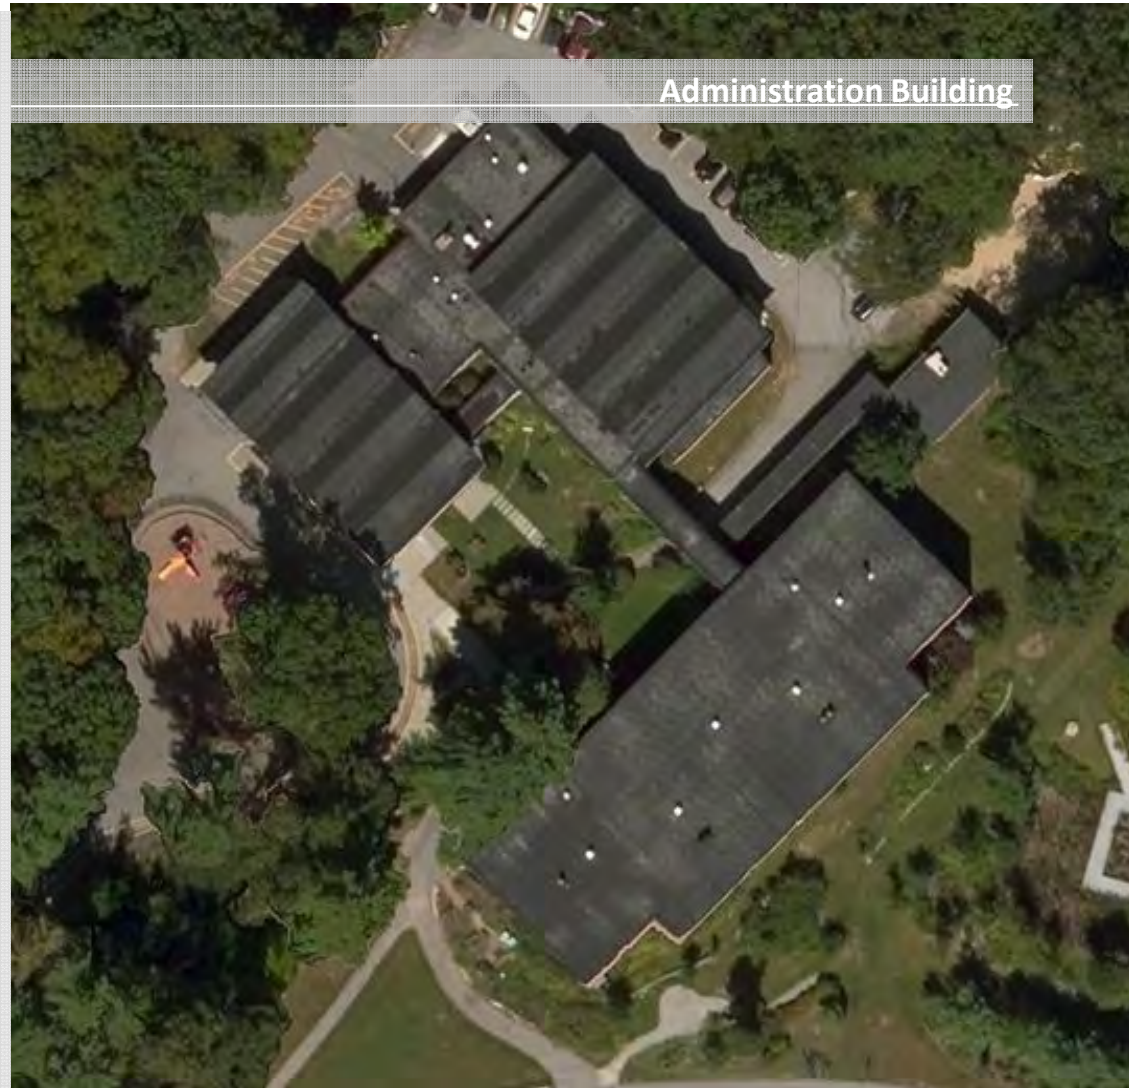
- Asphalt and concrete sidewalks are in poor condition
- PK playground in the middle of drive-loop; safety concern
- Drive-loop is inadequate; too small
- HC access is poor
- Parking is shared with Parker Damon;
- Confusing where to park, enter

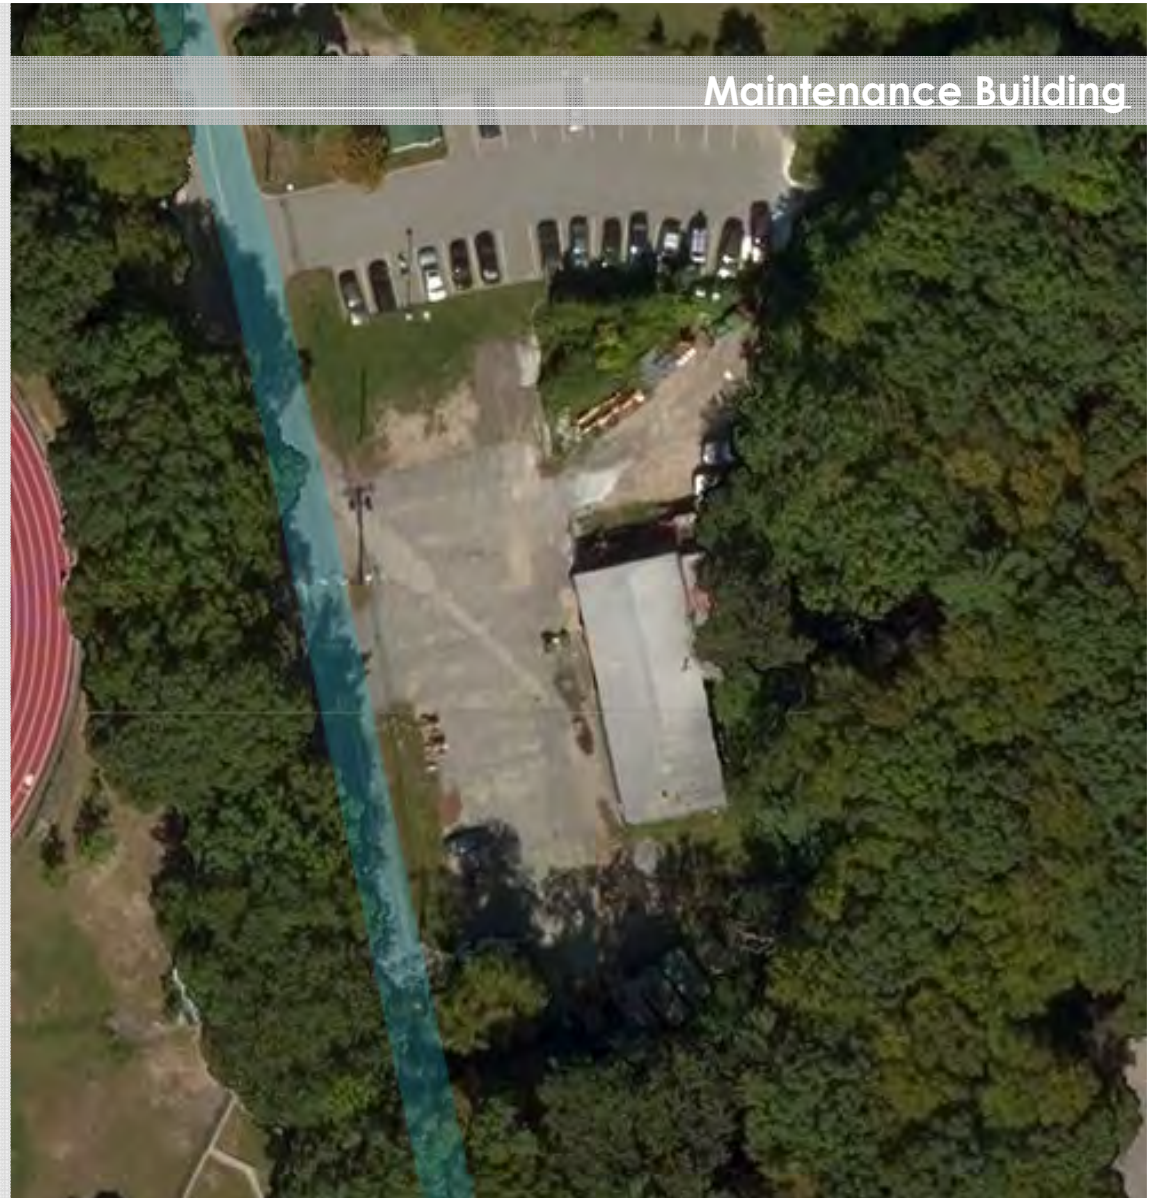
- Poor drainage: low point in front of building
- Pavement in poor condition
- Provide curbing to direct drainage and maintain pavement
- Site appears small
- Lack of vegetative screening

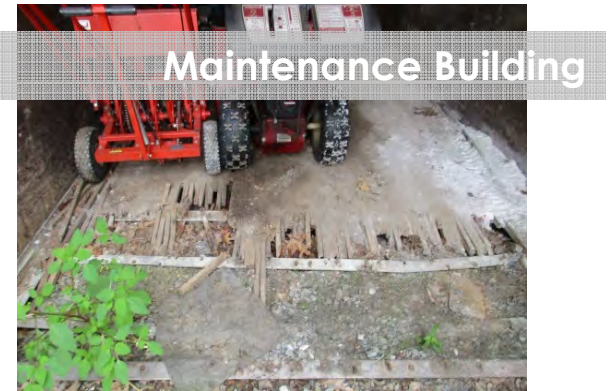
- Leaking Roof; exposed fasteners - rusting
- Poor insulation in walls and roof
- Lack of separation – welding, oil tank, heating furnace, vehicle repair
- Lack of separation – staff room, office area vs. vehicle bays
- No toilet room
- No wasteline serving the building; waste from sinks exits to daylight
- No hot water
- Busses cannot fit inside vehicle bay; problem in winter
- No parts storage; trailers are in poor condition
- 36 Busses maintained here
- No Fire Alarm
- Original Electrical Systems – Poor condition
