Acton Boxborough Regional School District School Facilities Assessment

Progress Presentation

19 November 2015

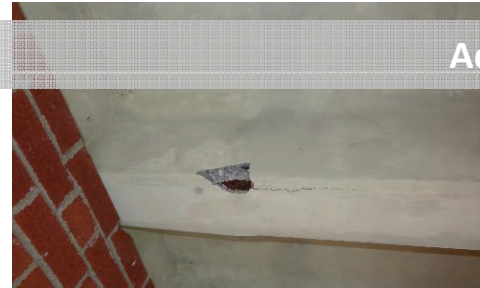
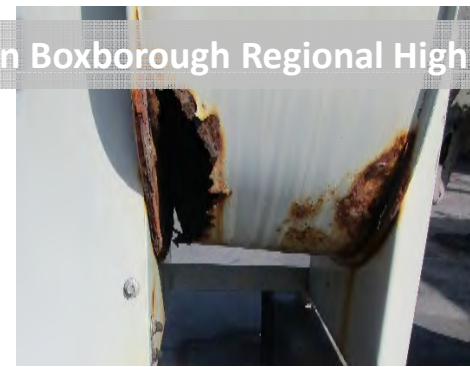
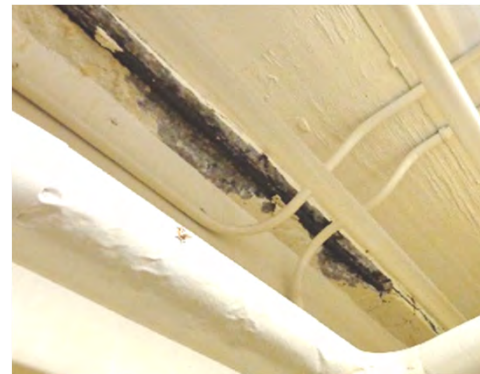
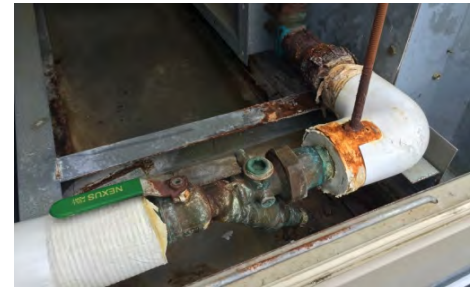
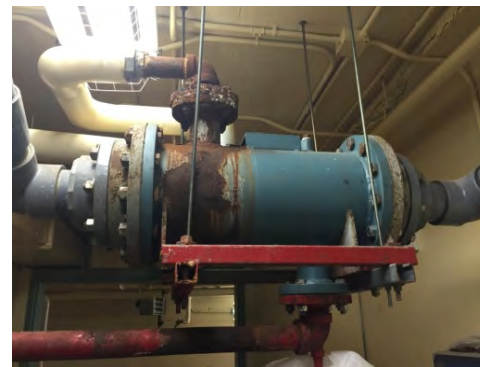
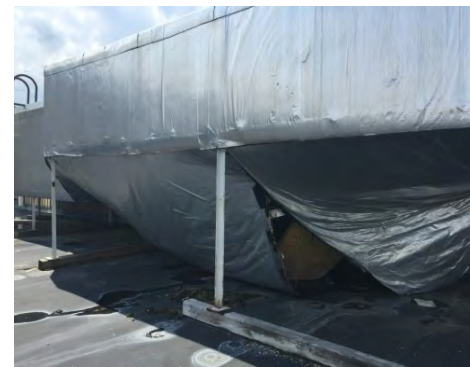
- Rooftop units are beginning to show signs of failure and corrosion; cooling and compressor failures as well
- Insulation is failing on the outdoor ductwork
- Some exhaust fan corrosion
- Actuator valves and isolation valves are failing
- Pool Unit: significant corrosion and failure
- Software glitches with HVAC controls

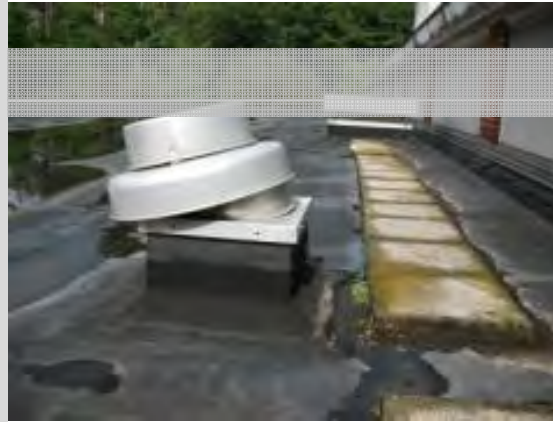
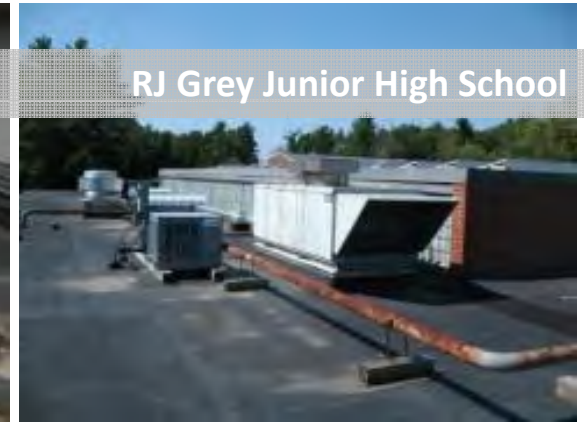
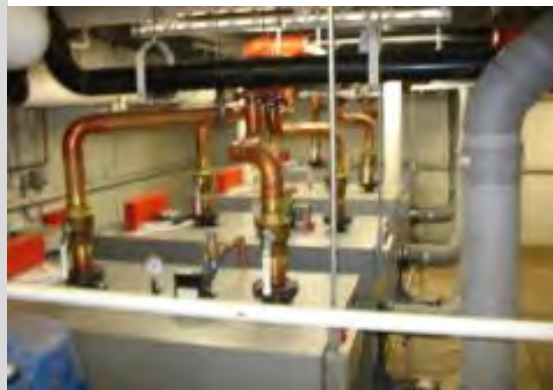
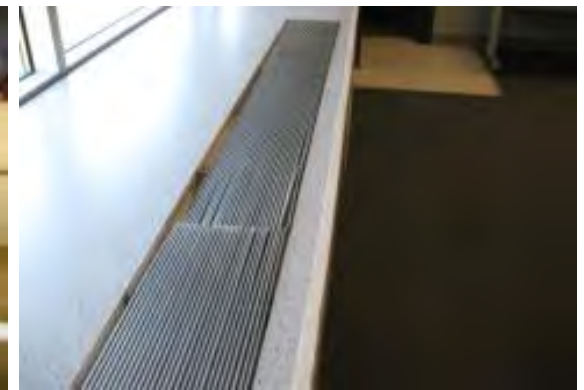
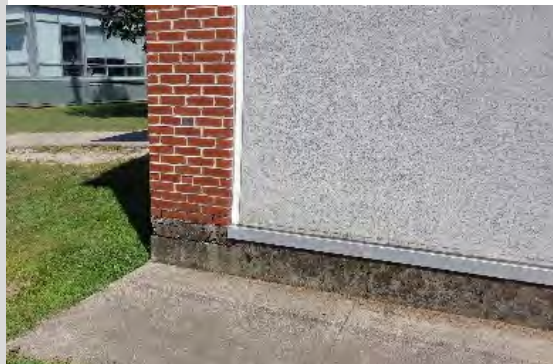
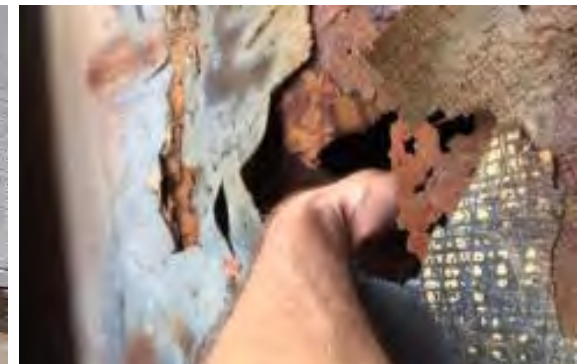
- Replace the following at roof:
 - corroded exterior ductwork
 - damaged insulation on exposed rooftop ductwork
 - 50% of rooftop exhaust fans
 - Damaged fan over the boiler room
- Install snow guards on the edge of the gym roof to protect equipment.
- Integrate rooftop exhaust fan control into the DDC control system
- Relocate the fancoil in the kitchen away from food areas.
- Add CO2 demand control ventilation control to the gym units.

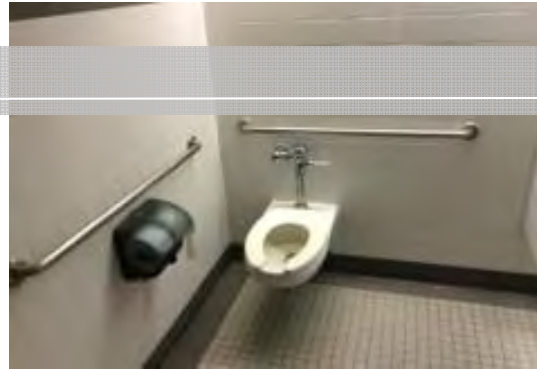
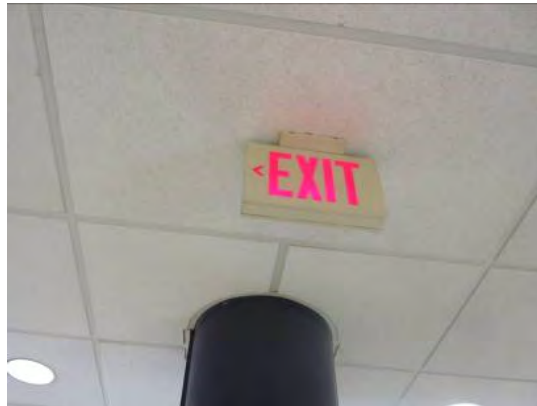
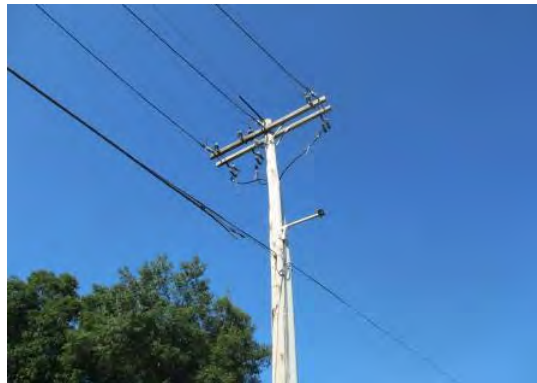
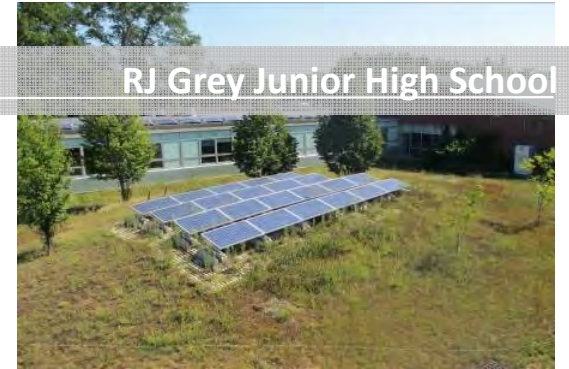
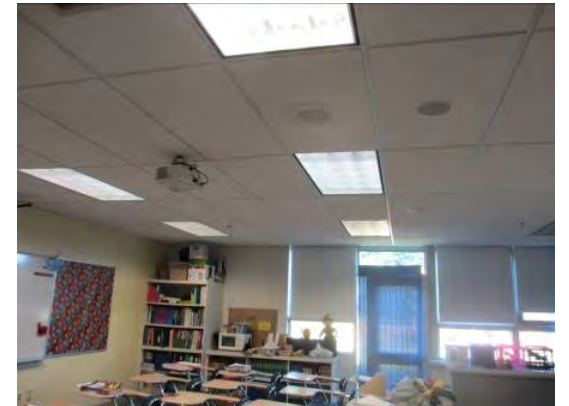
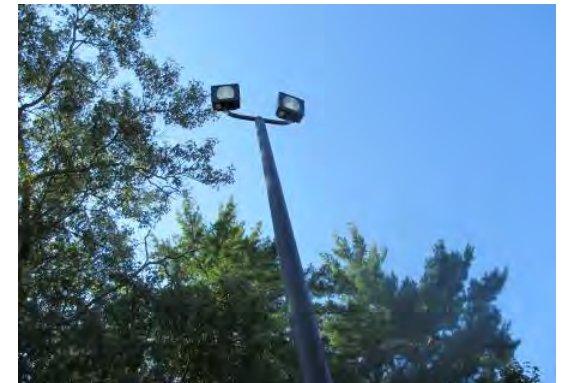
- SSMR sloped to flat EPDM roof - problematic
- Thermal loss at aluminum windows/ panel system; wood frames rotting
- Reverberation at main entry clerestory
- Finishes/built-ins range in condition
- HC accessibility concerns - toilet rooms; water fountains; casework; side clearances at doors

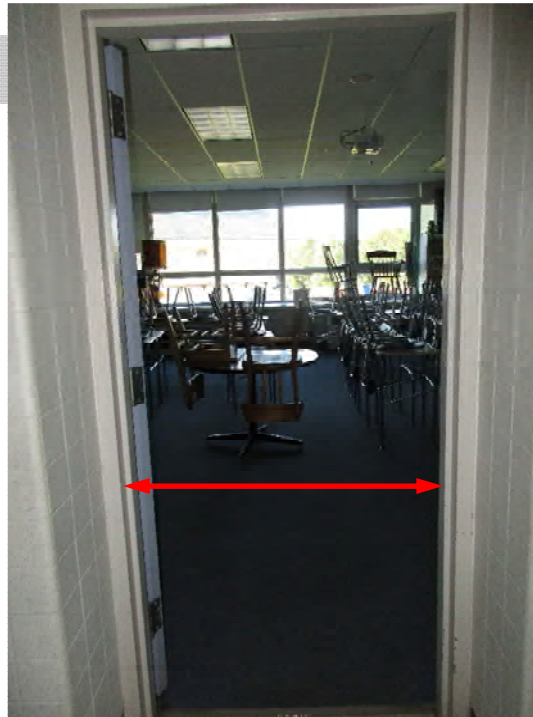
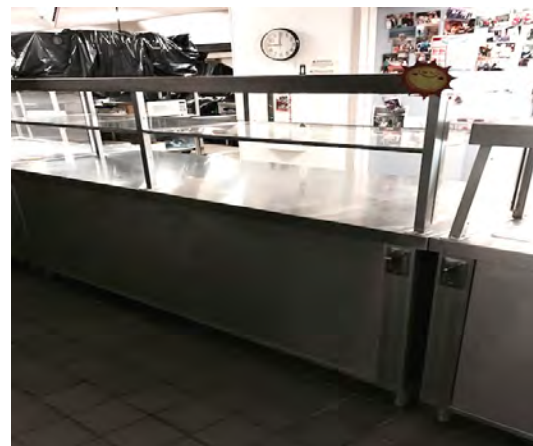
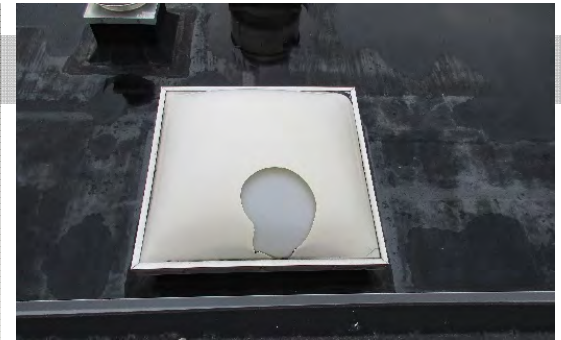
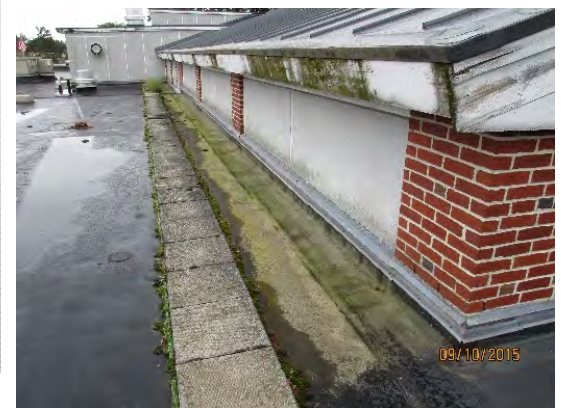
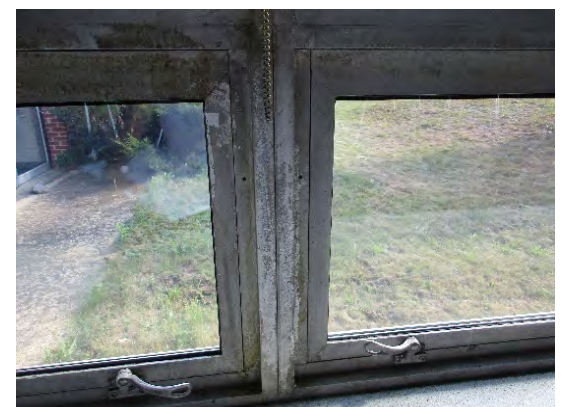
- AHU leaking above serving counter
- Sneeze guards at serving line are outdated and non compliant anymore
- Milk coolers are not HC accessible

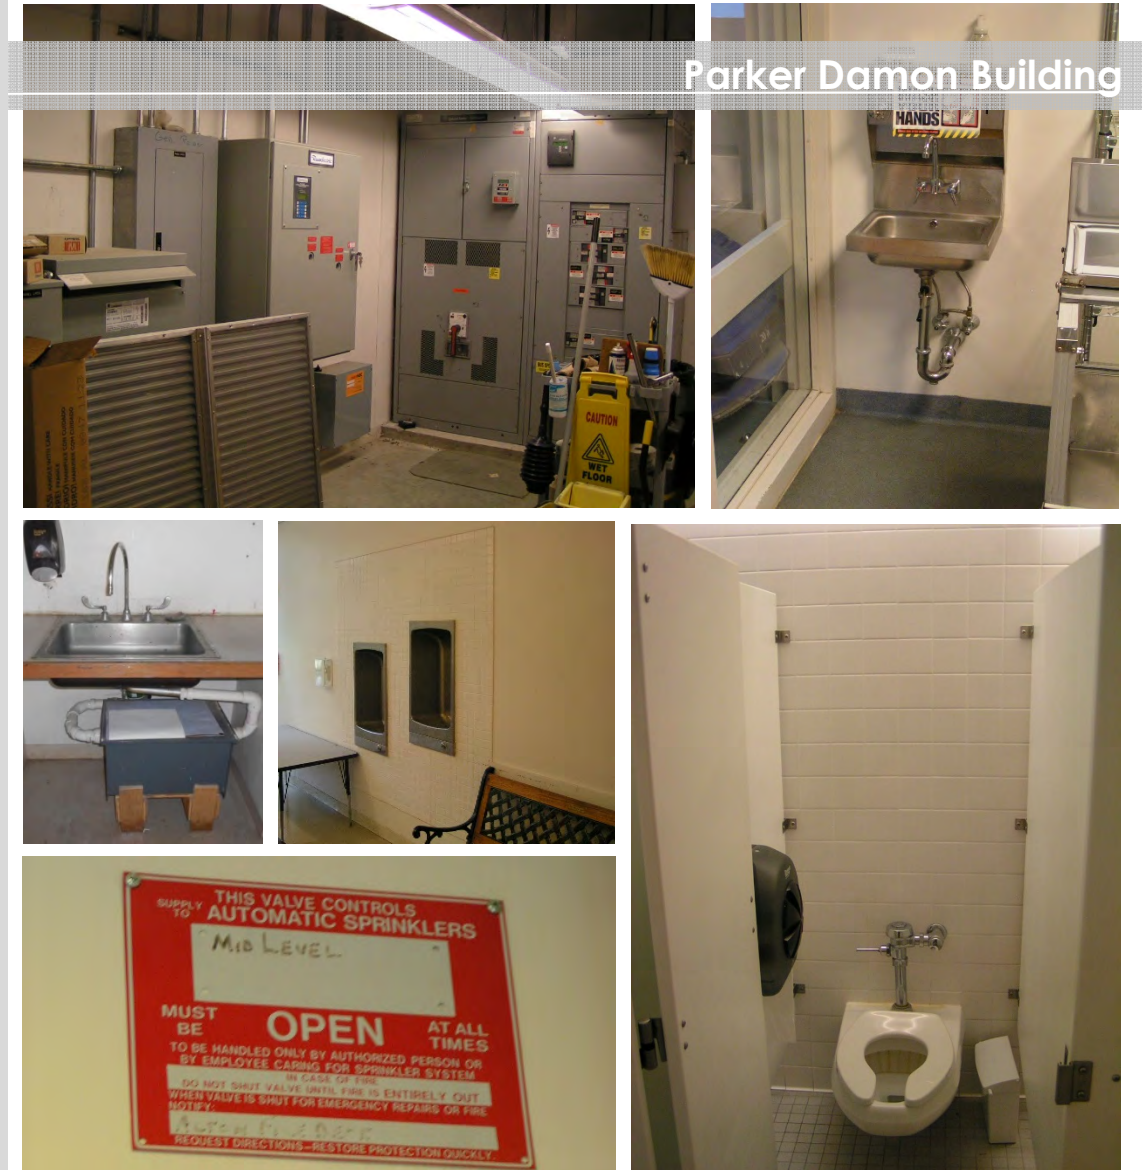
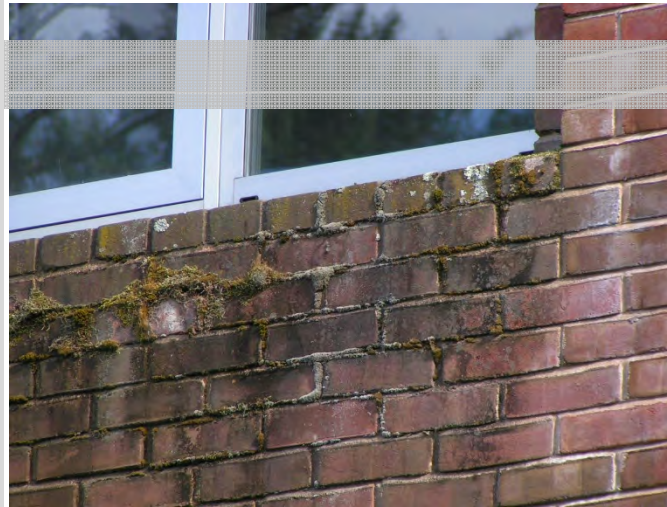
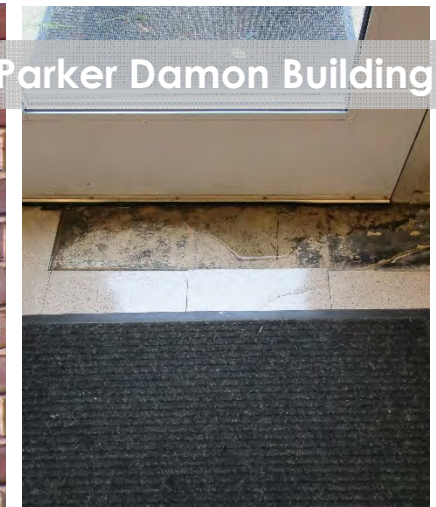
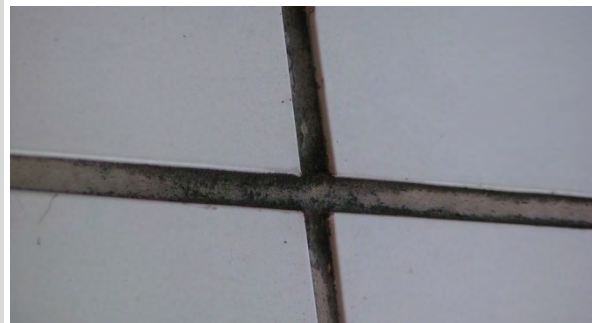
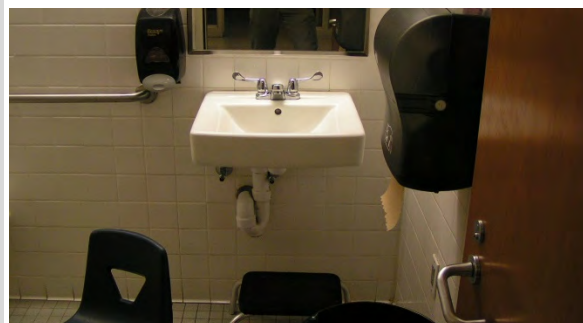
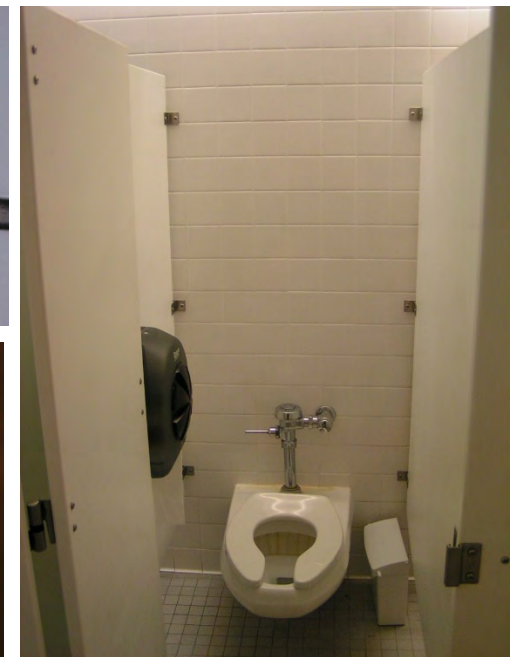
- Brick sills failing, coming apart at mortar joints, high levels of water absorption, staining, moss growth
- Failure of thresholds at lower level allowing water to enter building, affecting floor tile
- Failure of sealants at metal wall panels
- Accessibility clearances impeded at some doors

- Gaps between equipment and adjacent surfaces exceed food code
- Exhaust hood separating from wall, needs to be reviewed for structural soundness
- Heat trace at walk-in cooler vision panel failing

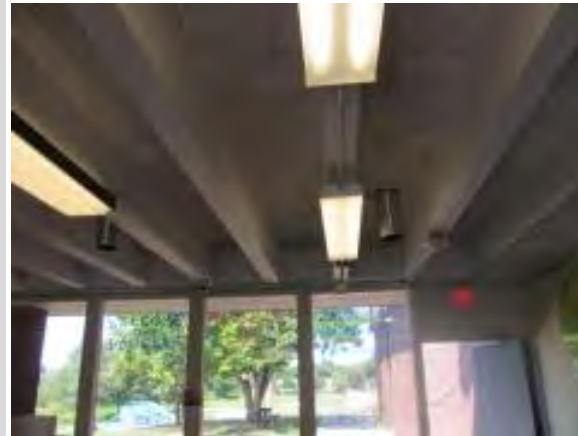
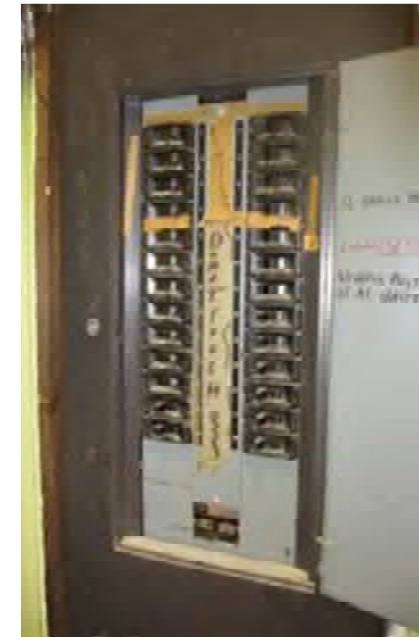
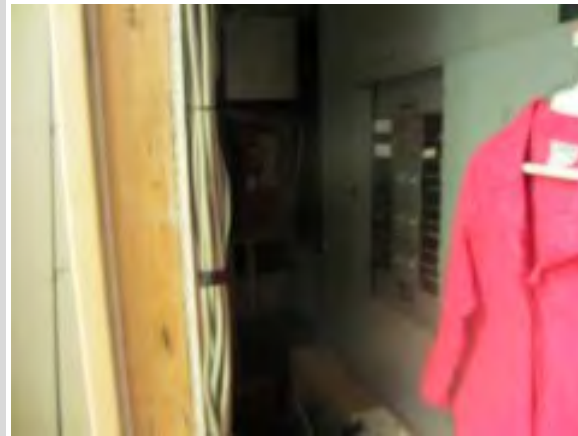
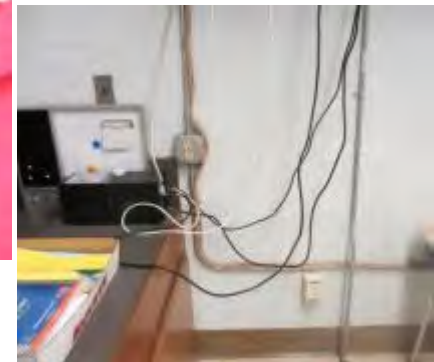
- New service main is behind wood stud partition- no clear space- not code compliant
- Remainder of the electrical distribution is in poor condition and is beyond its serviceable life.
- Existing panelboards are original Federal Pacific. No spare capacity left
- Recommend upgrade to LED's occupancy and daylighting controls
- No emergency generator
- Fire Alarm: fair condition- does not meet current code

- No sprinkler system

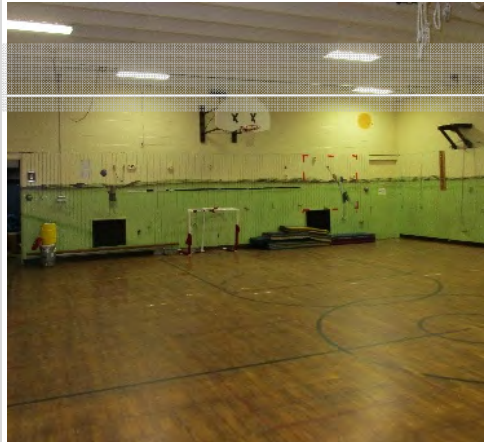
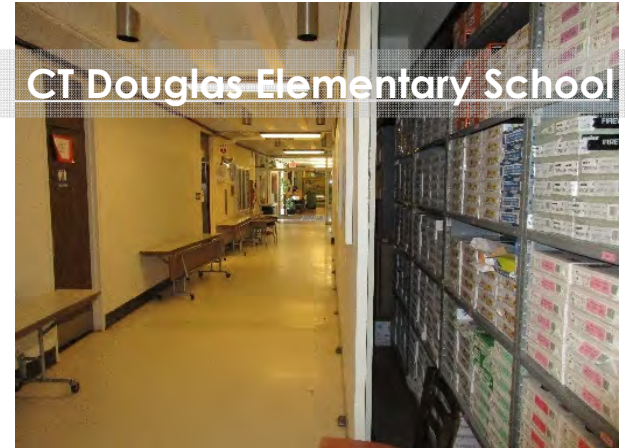
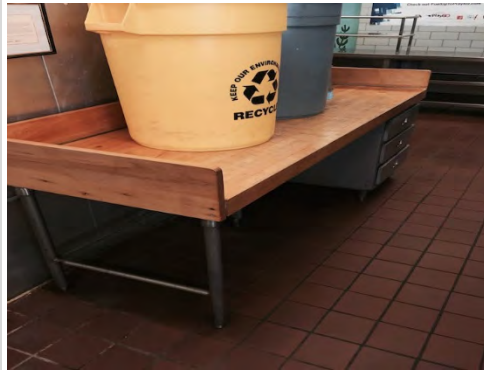
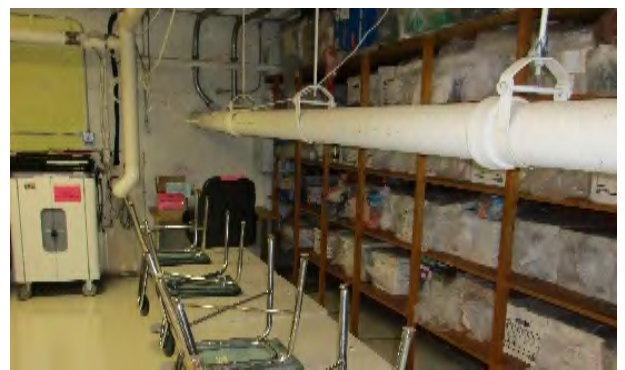
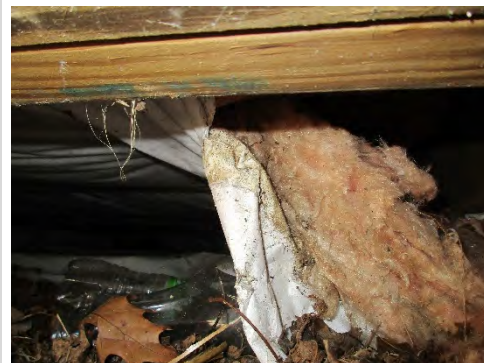
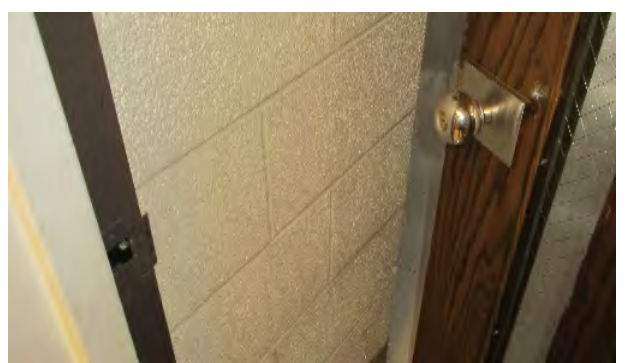
- Modularity: poor condition- fiberglass insulation failing
- No insulation in exterior walls
- Single pane windows
- Ice-damming and leaking at modularity
- Original wood floor in gym; failing
- Gym ceiling is low: 14'
- Lower classroom floor and platform not accessible
- Classrooms: not accessible due to lack of clearance at doors and knob handles
- Paper storage in corridors
- Waste line at 5' high in storage/pull-out space
- Dirt crawl space- adjacent to occupied space

- Replace wood top table with stainless
- Range is outdated- inefficient
- Dry goods storage is undersized
- Serving counter is antiquated- cannot keep chilled food cold

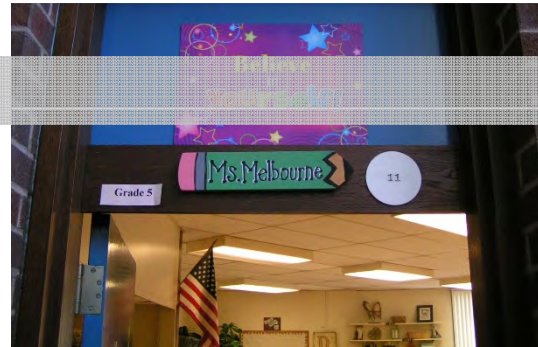
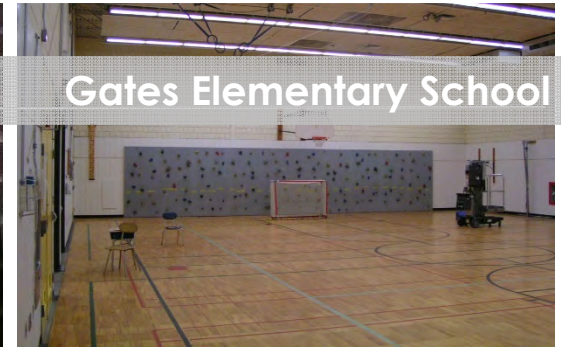
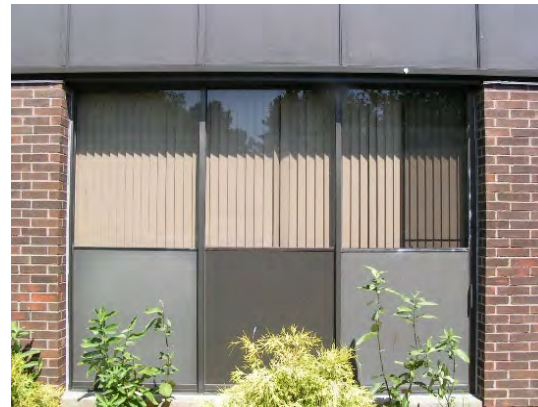
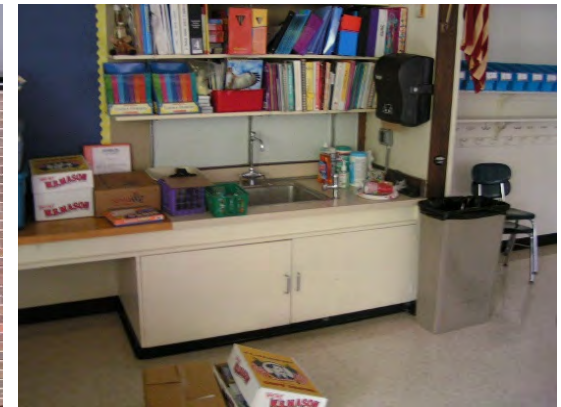
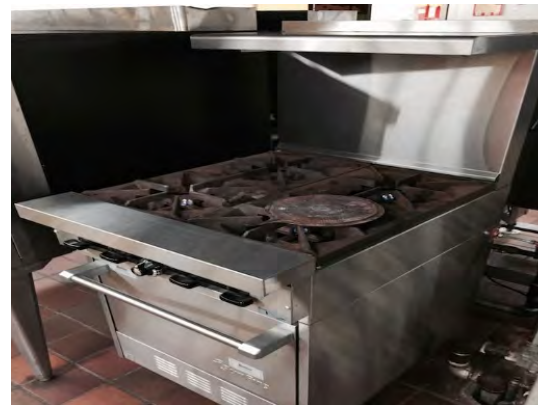
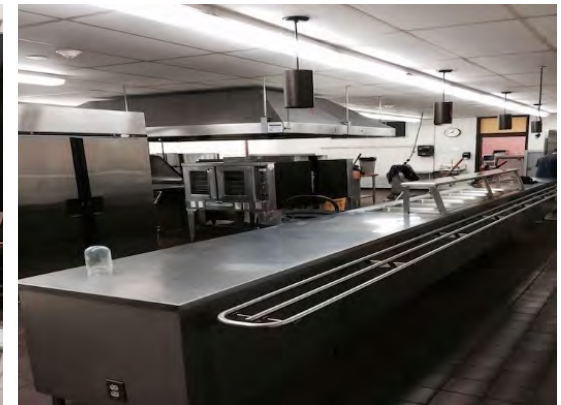
- Suspect materials are expected due to building age but maintained well. Prior to any repairs, check AHERA reports and perform testing if needed.

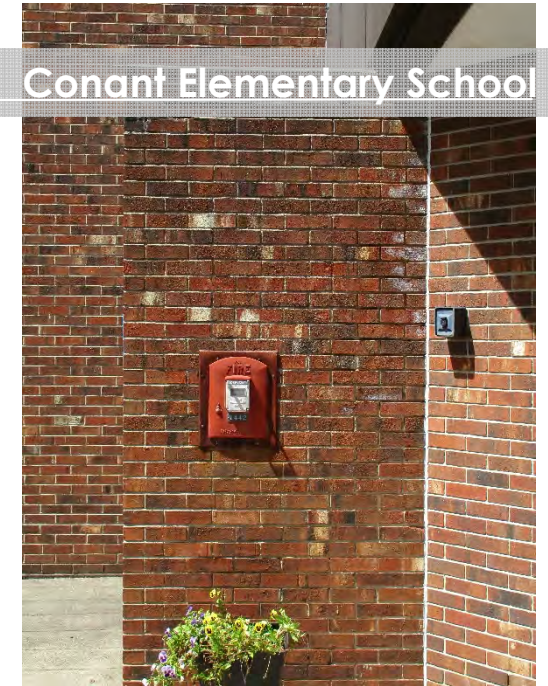
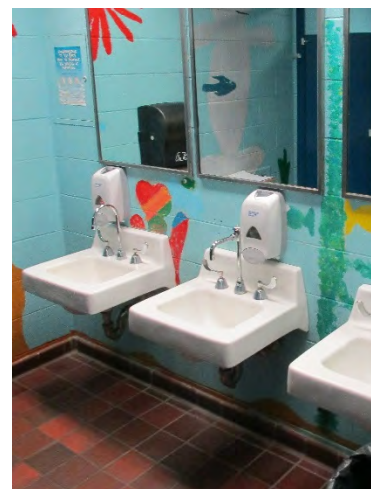
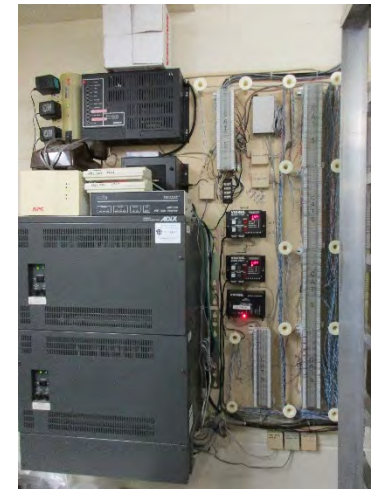
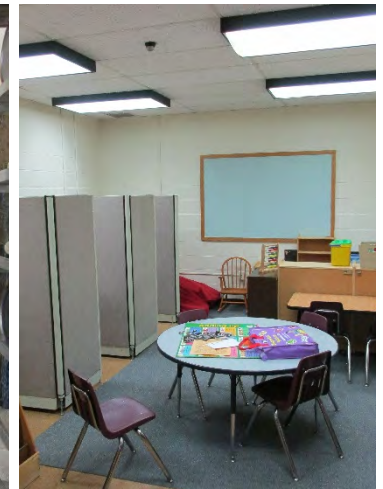
- Building is not sprinklered

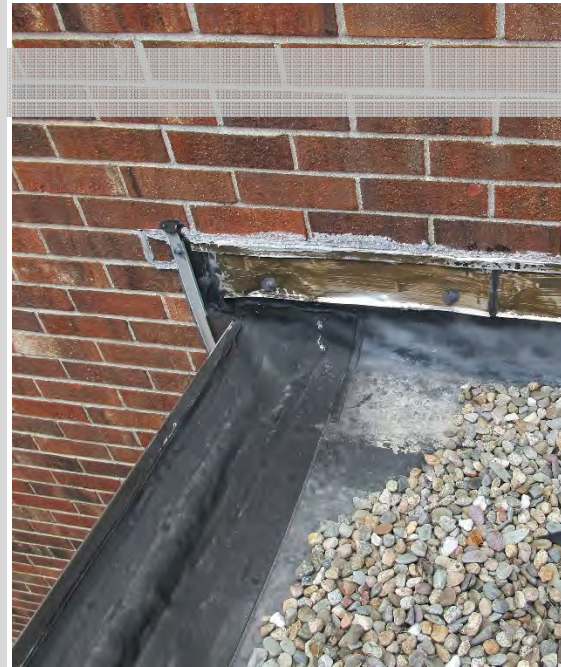
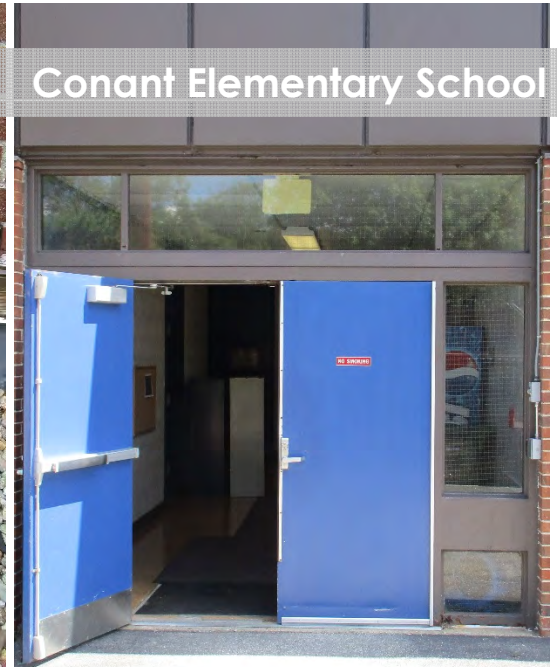
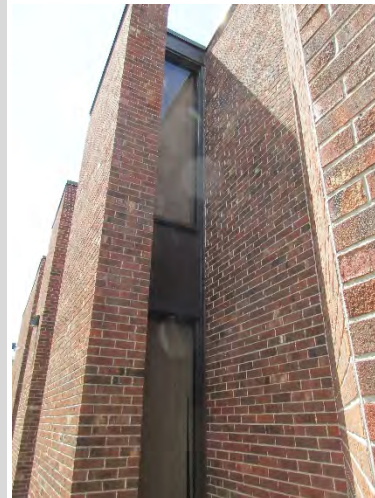
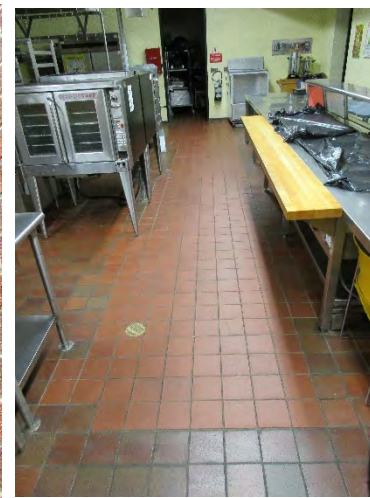
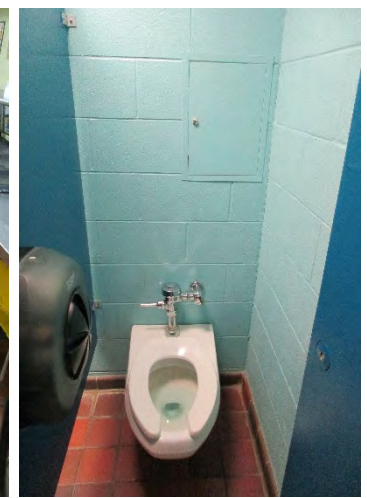
- Suspect materials are expected due to building age but maintained well. Prior to any repairs, check AHERA reports and perform testing if needed.

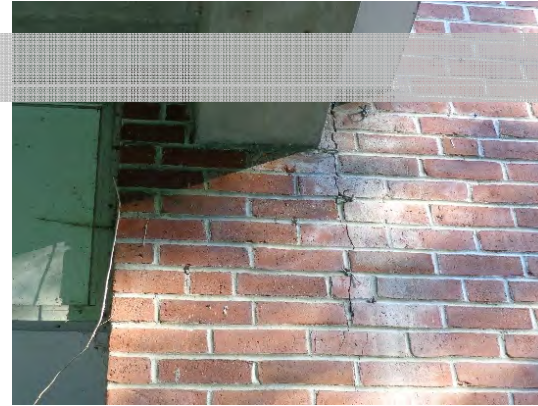
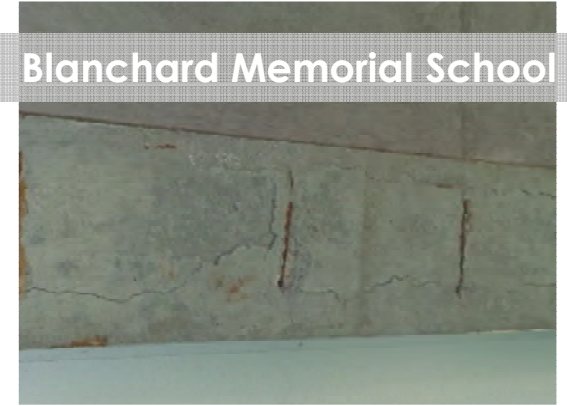
- Cracking at interior and exterior of building – typically minor but repair
- Canopy at back of building has cracked façade and concrete beam is cracking and corroded

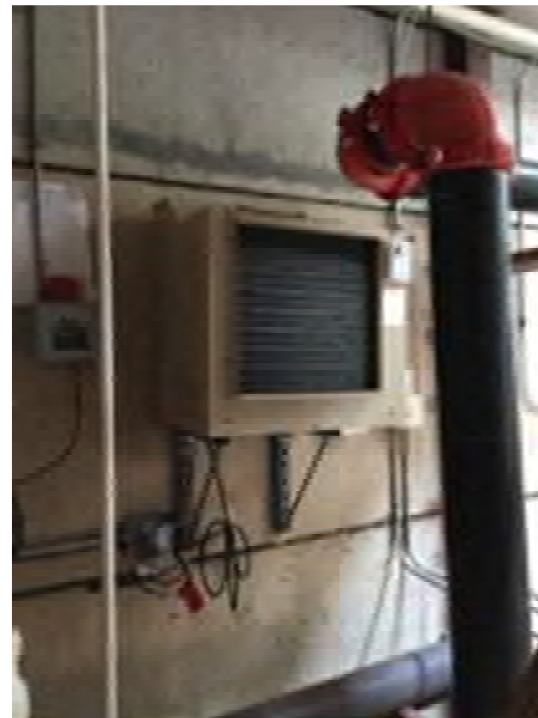
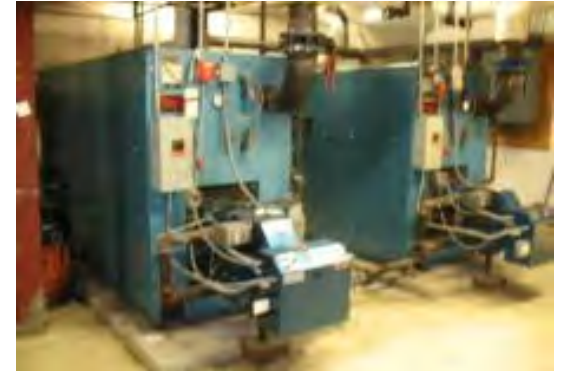
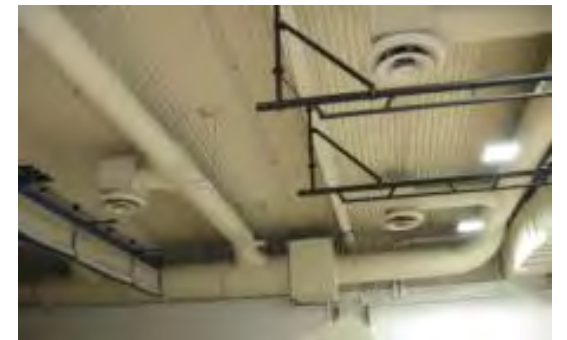
- Corridors do not have ventilation
- Condensation issues in fire pump pit; dehumidification added.
- Replace cooling equipment that utilizes R-22 refrigerant
- Pipe and breeching insulation is damaged/failing/ missing and should be replaced
- Upgrade to DDC
- Add CO2 demand control ventilation control to high occupancy spaces

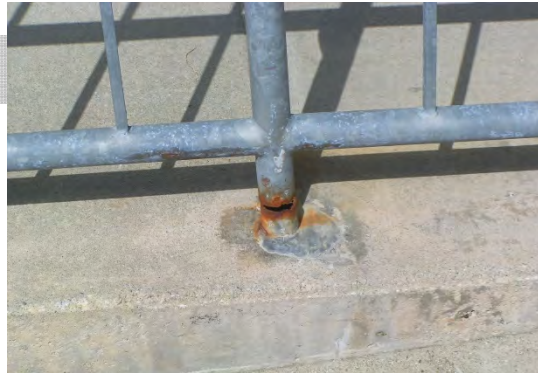
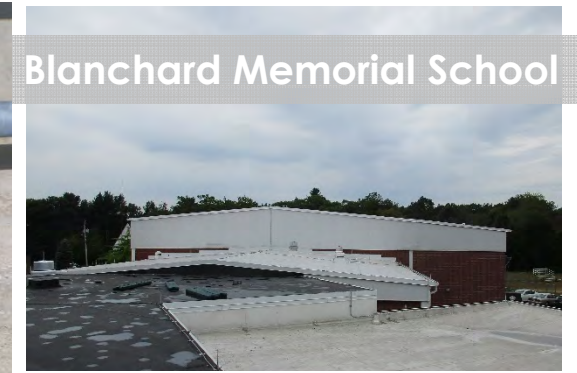
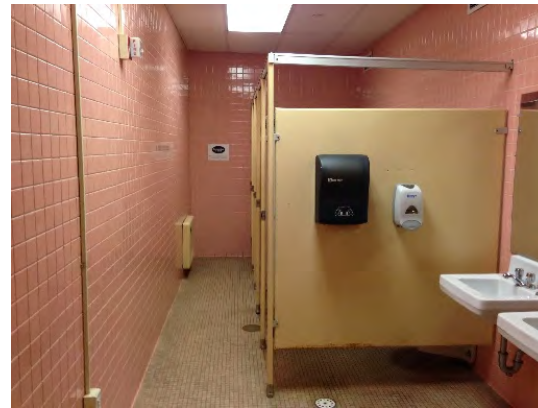
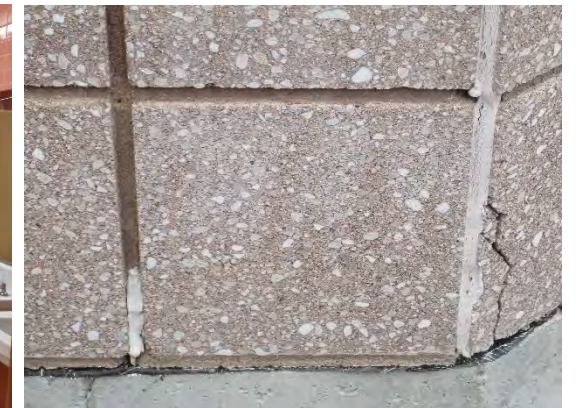
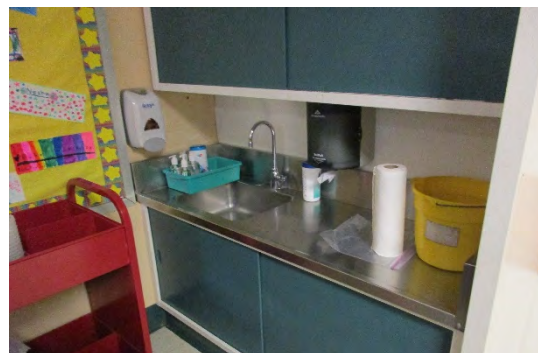
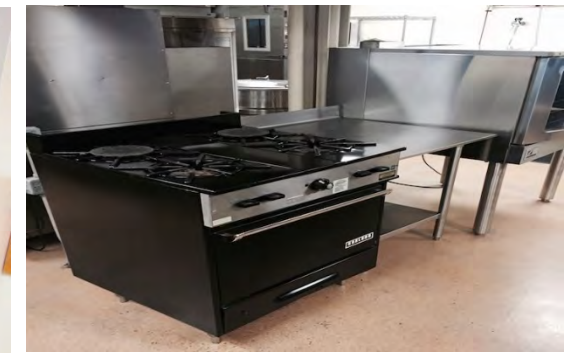
Blanchard Memorial School

- Exterior in good condition overall
- Rusted posts at ramps
- Weep holes filled in with caulk
- Finishes/built-ins vary in condition
- HC accessibility issues - toilet rooms; water fountains; casework; side clearances at doors

- Floor and ceiling should be replaced
- Well equipped but in need of modern range, freezer, additional fridge, and stainless steel worktables

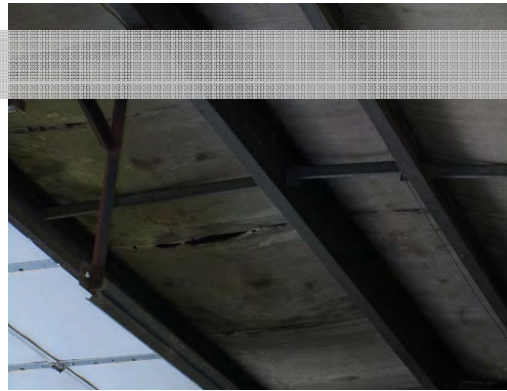
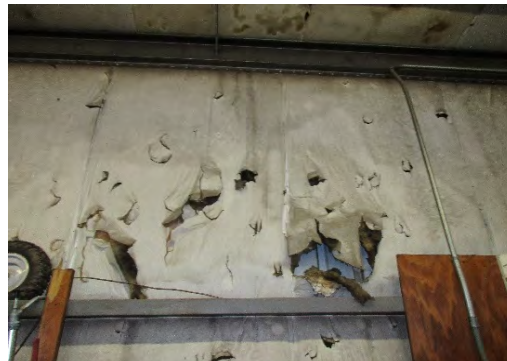
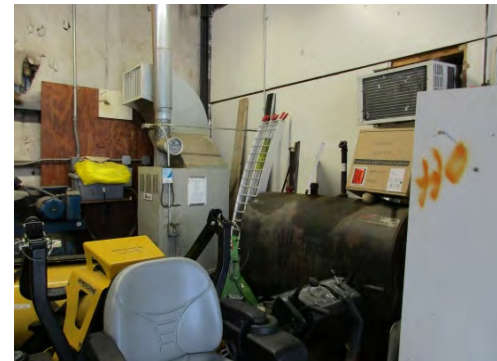
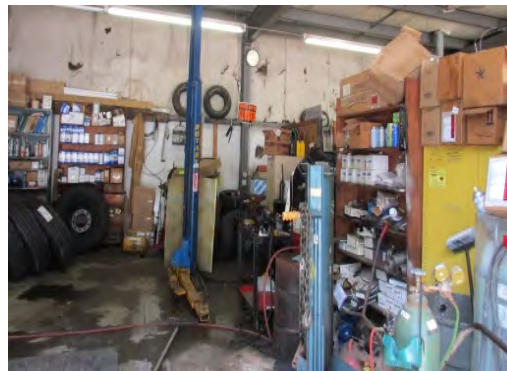
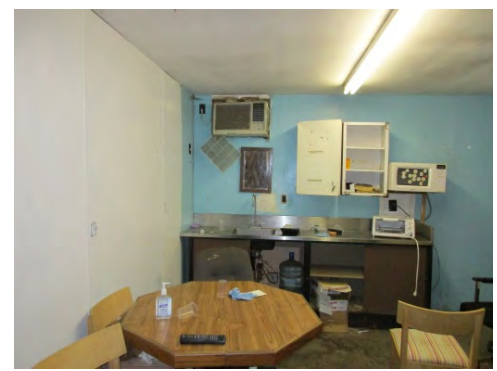
- Leaking Roof; exposed fasteners - rusting
- Poor insulation in walls and roof
- Lack of separation – welding, oil tank, heating furnace, vehicle repair
- Lack of separation – staff room, office area vs. vehicle bays
- No toilet room
- No wasteline serving the building; waste from sinks exits to daylight
- No hot water
- Busses cannot fit inside vehicle bay; problem in winter
- No parts storage; trailers are in poor condition
- 36 Busses maintained here
- No Fire Alarm
- Original Electrical Systems – Poor condition
